Manhole Inspection Summary

Manhole # S15II1023MH

Location Address: **2431 COLD SPRING LN**

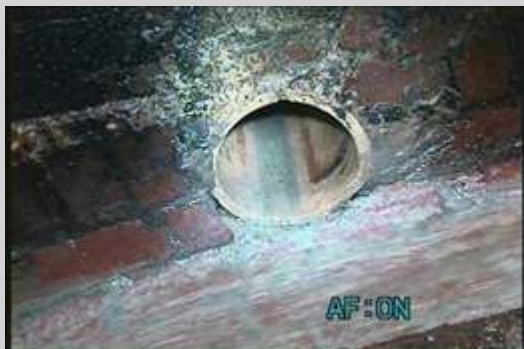
6 in. Circular Gravity Sewer Pipe In @ 3 O'Clock

Pipe Material: **Clay** ☐ Pipe Lined

Invert Depth: **8.80** (ft.) Flow Characteristics: **Slow**

Deposits: ☒ None ☐ Mud ☐ Sludge ☐ Debris ☐ **Grease**

Infiltration: **None**

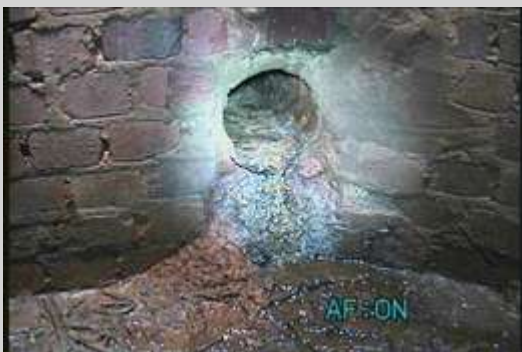
6 in. Circular Gravity Sewer

Pipe Material: **Unknown** ☐ Pipe Lined

Invert Depth: **7.60** (ft.) Flow Characteristics: **Slow**

Infiltration: **None**

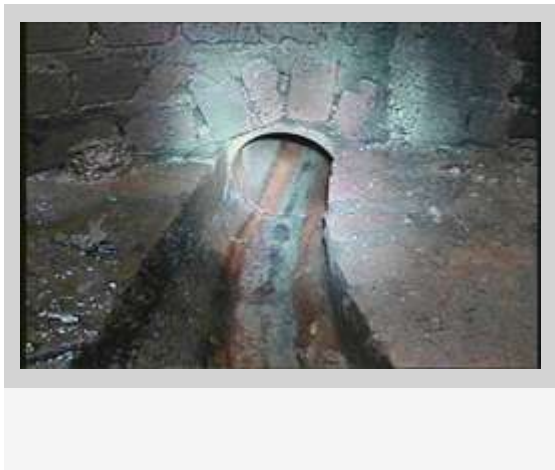
6 in. Circular Gravity Sewer
Pipe In @ 9 O'Clock

Pipe Material: **Clay** ☐ Pipe Lined

Infiltration: **None** Pipe Seal Cond: **Unknown**
